## MARINE INVESTIGATION REPORT

M00M0106

### GROUNDING

*TUG KETA V*

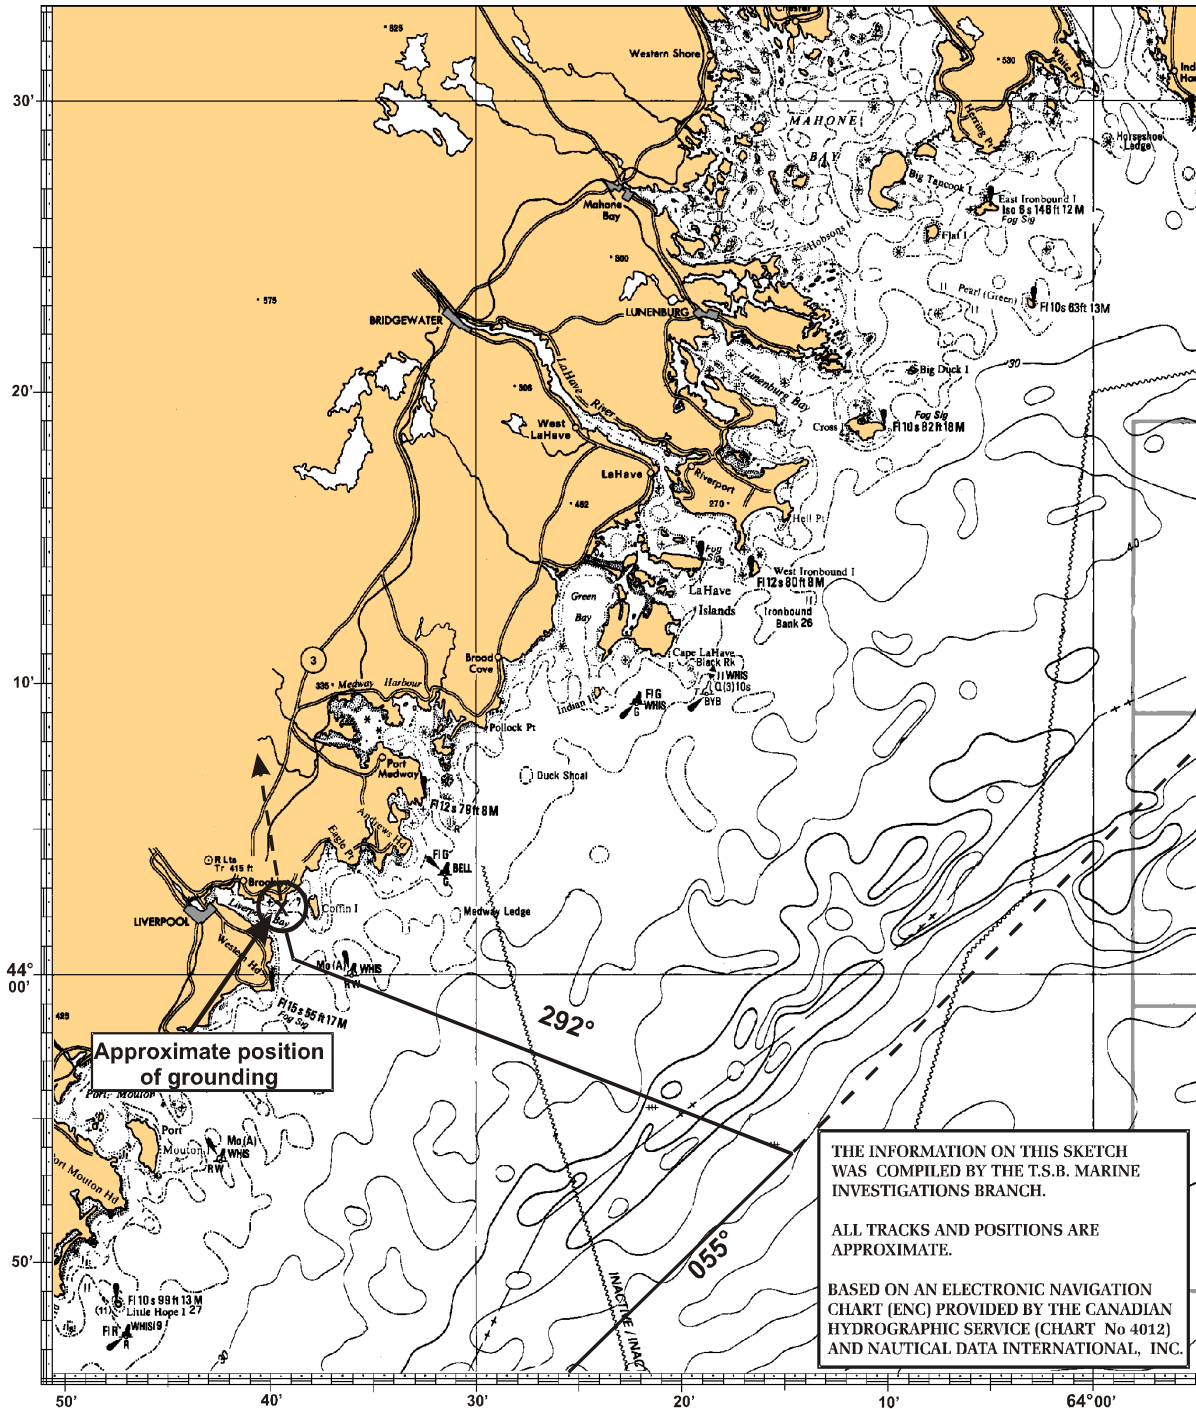
# Appendix A – Small-Scale Chart Used on the Keta V

To enable the master to plan his approach to Liverpool Bay, Canadian Hydrographic Service general chart L/C 4012, covering the area from Yarmouth to Halifax, Nova Scotia, was used as a reference. Although there are large-scale charts<sup>3</sup> covering Liverpool Bay, these were reportedly not found on board the tug. L/C 4012 is a small-scale chart, so it does not show any of the references required to navigate the Liverpool Bay approaches. Because the master had never sailed into this harbour, he based his approach plan on his experience in other ports and on information he had received some time earlier from an acquaintance who once worked for a paper manufacturer in Liverpool. The master and the helmsman were in the wheelhouse.

Small-scale charts are intended for offshore navigation only. They contain enough detail, but they only allow the mariner to locate harbour approaches. Approaches are made on a large-scale chart with an inset showing a detailed plan of the harbour, as recommended in the *Charts and Nautical Publications Regulations*.<sup>5</sup> Although large-scale charts covering the Liverpool Harbour area are published, these were not on board and, therefore, could not be used. The basic principles of seamanship require that a vessel should not attempt to enter a port without the largest-scale current marine chart of the area.

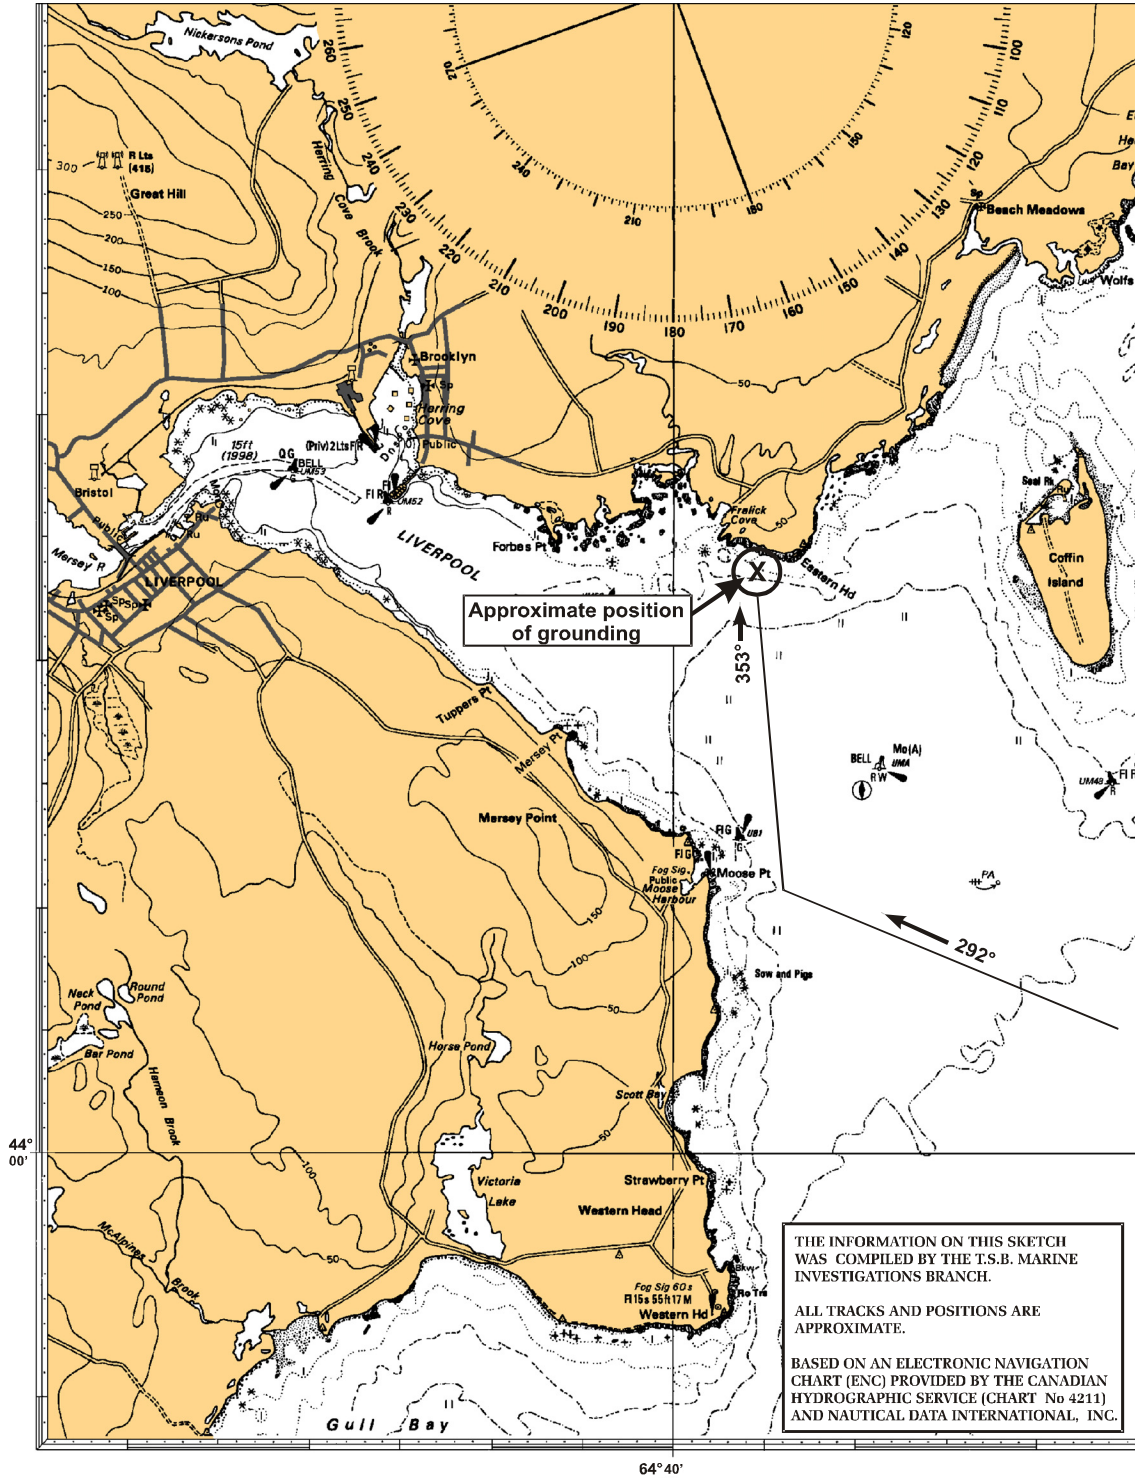
# Appendix B – Chart of the Occurrence Site

The approach plan was to proceed on a heading of 292° T, to a position southeast of Moose Point. The engines were set to reduced speed. (See Appendix B.) On arriving at Moose Point, the master altered course to 353° T and headed for Eastern Head. While under way, the master's primary concern was to watch for presumed range lights indicating the entrance to Liverpool Harbour, which, according to him, should have been seen on the port side. The range lights were not seen. The tug maintained heading, and at 2328, it grounded on a rock shoal off Eastern Head.
